Lithium Batteries - Not as safe as you might believe!

By Ann Roffey

Response from David Keenan

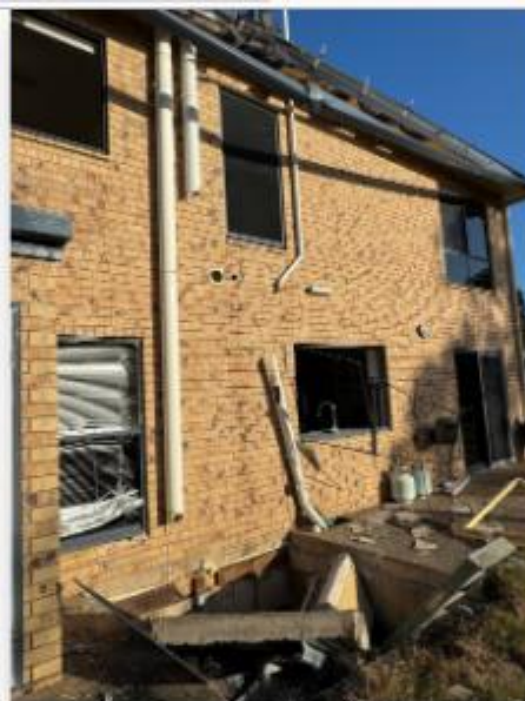
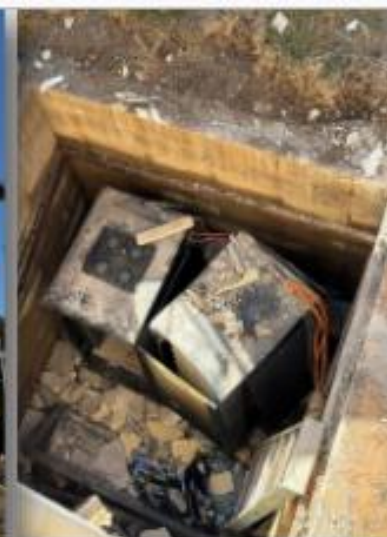
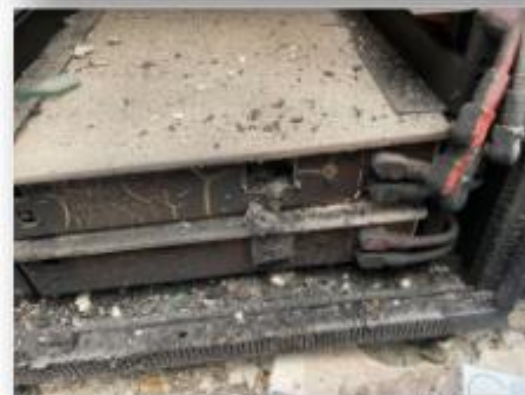
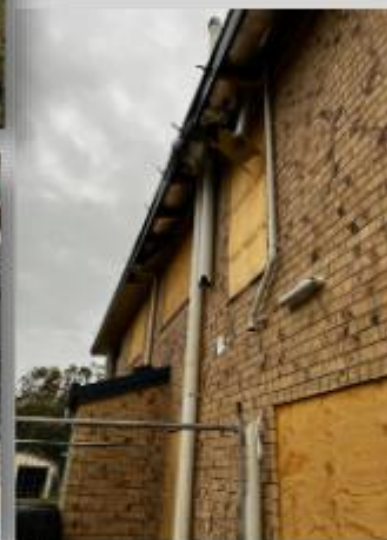
Damage from the lithium battery explosion at my Aunt and Uncle's house. They moved their bedroom to the other end of the house, as it was right above the explosion and sustained significant damage.

The kind of lithium battery modules we can see, housed in the kind of 19" racks we can see, are not approved for outdoor installation, nor are they approved for installation in an environment with extreme humidity and water condensation as would be inevitable in such a pit. You can see a line of dampness on the brickwork inside the pit in one photo.

Most informative is the bottom left photo, a close-up of two modules in the bottom of a 19" rack. In another photo we can see that there is another 19" rack which looks undamaged apart from debris and possibly bootprints on top of it. It looks to be full of battery modules and so it presumably houses the other 10 modules of the 12 referred to in the text.

But when we zoom in to the two-module rack, we can see that the modules were originally white. And we can see part of a logo on the ground that looks like it begins with "C Po". I eventually found they are made by Power Plus Energy, an Australian company, and are almost certainly the older Eco4840P model because you can make out some blue text behind the soot, where the newer Eco4847 model has black text and a different looking

We can also see that the double-pole circuit breaker in the upper module has completely melted and puddled onto the top of the module below. But the lid of the upper module is not charred at all. This puddle suggests that this circuit-breaker was arcing for many minutes. The starting of this arc would have ignited the fuel-air mixture in the pit, and blown the cream coloured plastic door of this rack to pieces before propagating to the rest of the pit and the vent pipe and causing all the damage we can see. But the arc would have had to continue for some time after the explosion.

The only hypothesis I can come up with is that water condensation, or possibly ants, created a current path between the positive and negative poles of the circuit breaker allowing an arc to track across the surface. It may have taken months or years for this tracking to build up to the point where it arced over.

But no matter what the sequence of events, the primary cause of the explosion was the siting of perfectly-good CEC-approved indoor-rated (IP40) battery modules in an outdoor pit.
